DELAWARE RIVER BASIN

GOOSE POND RUN, MONROE COUNTY
PENNSYLVANIA

SOIL CONSERVATION SERVICE
DAM PA-464

PHASE I INSPECTION REPORT
NATIONAL DAM INSPECTION PROGRAM.
Soil Conservation Service DAM PA-464.
(Goose Pond Run Dam). NDS ID PA-00812.
DER ID 45-247. Delaware River Basin,
Goose Pond Run, Monroe County,
Pennsylvania. Phase I Inspection Report.

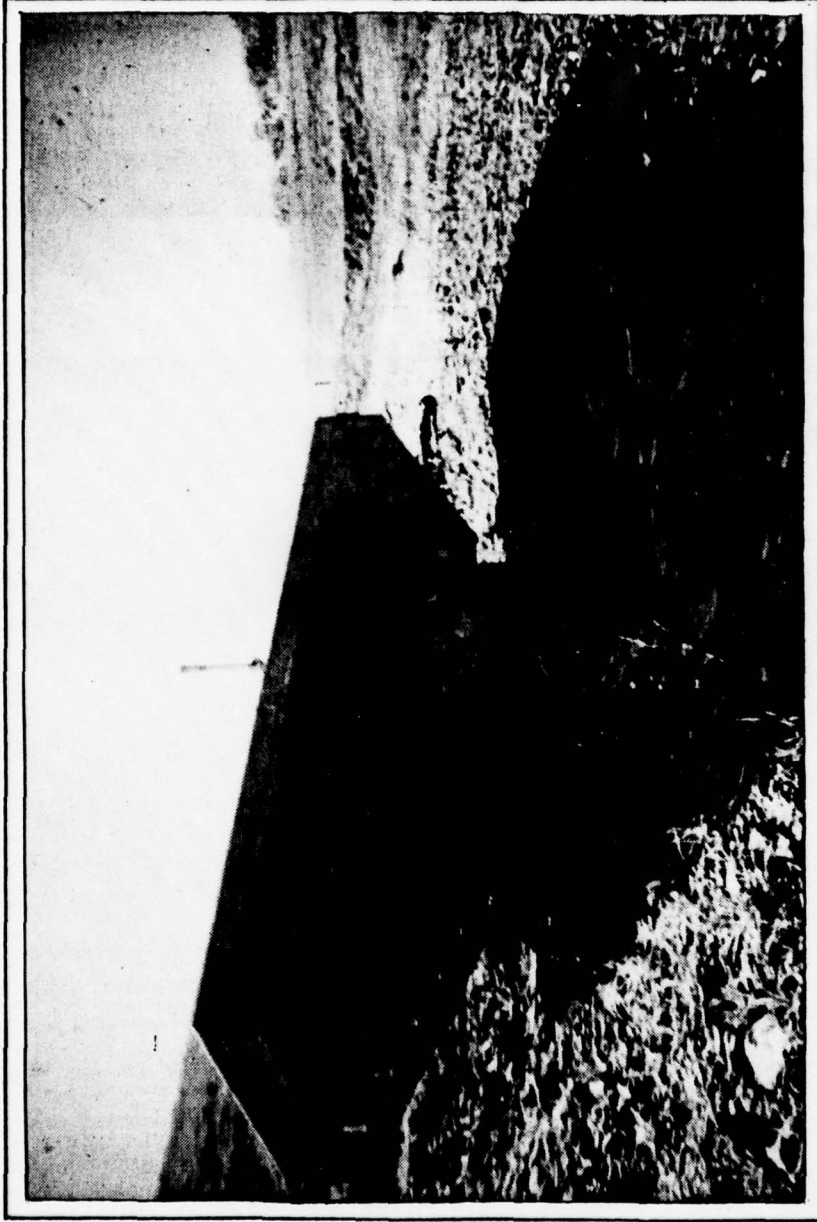
PHOTOGRAPH NO. 1

1. Intake Riser. As shown on Photograph 1, the riser is located within the upstream embankment, and water flows over weirs at the top of the riser or through the pond drain at the riser base, shown on Photograph 2. The exposed portions of both intakes were carefully inspected and evaluated to be in good condition with no signs of concrete deterioration, spalling or other structural deficiencies. Similarly, the impact basin at the downstream toe was also inspected and observed to be in equally good condition, with no signs of distress, deterioration or other structural deficiencies. The interior of the intake riser could not be inspected in that it was not readily accessible.

INTAKE RISER ON UPSTREAM SLOPE.

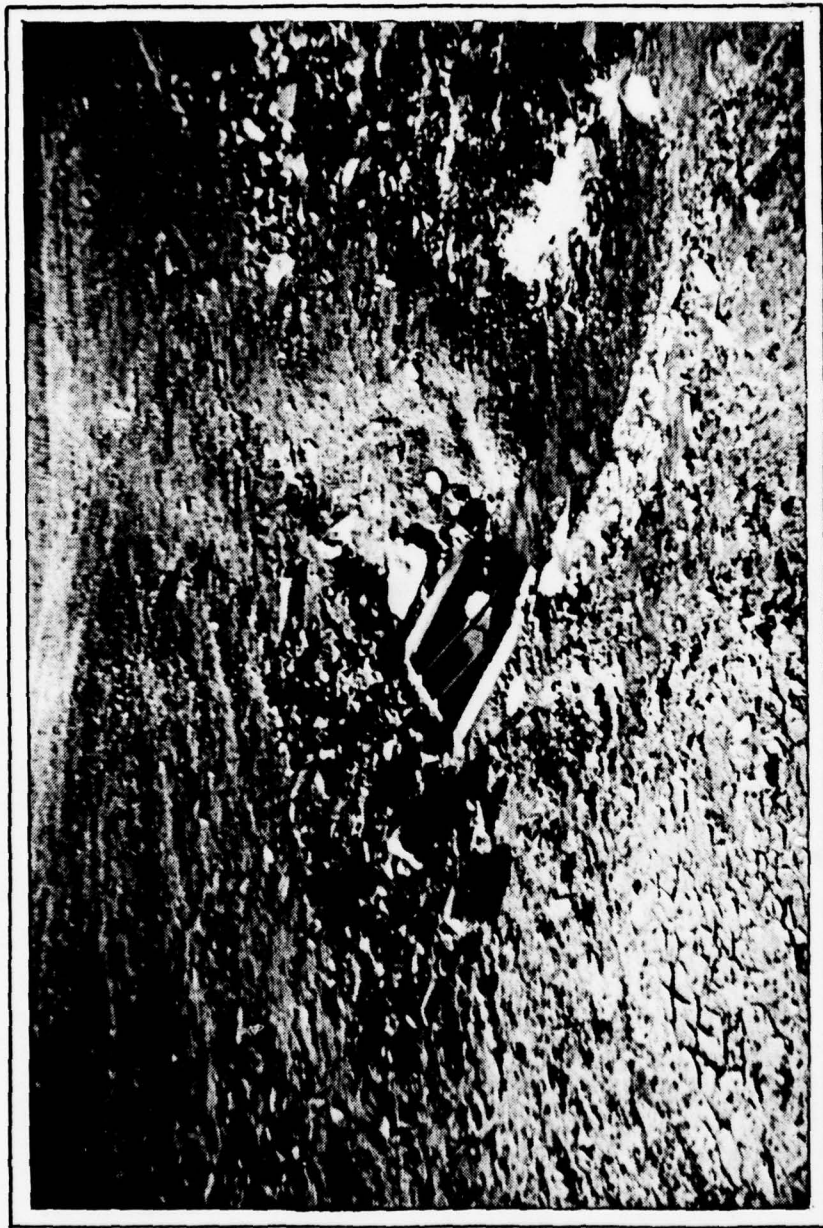
It is noted that the pond drain was open due to a malfunctioning gate allowing for no sedimentation storage.

d. Reservoir. At the time of inspection, the pond drain was open because of a malfunctioning gate, eliminating all storage behind the dam. However, the pond created by the older dam retains a small quantity of water. This dam is considered to be in poor condition. However, if this dam failed at any time, it would have no significant impact on the structural integrity of the dam or its intake system. Reconnaissance of the remaining portion of the reservoir disclosed no evidence of significant siltation, slope instability, or other features that would significantly affect the flood storage capacity of the reservoir.

POND DRAIN INTAKE.

1. The jammed pond drain valve should be repaired.
2. Debris along the sides of the reservoir should be cleared to some reasonable degree to minimize the potential for clogging the principal spillway intake system.

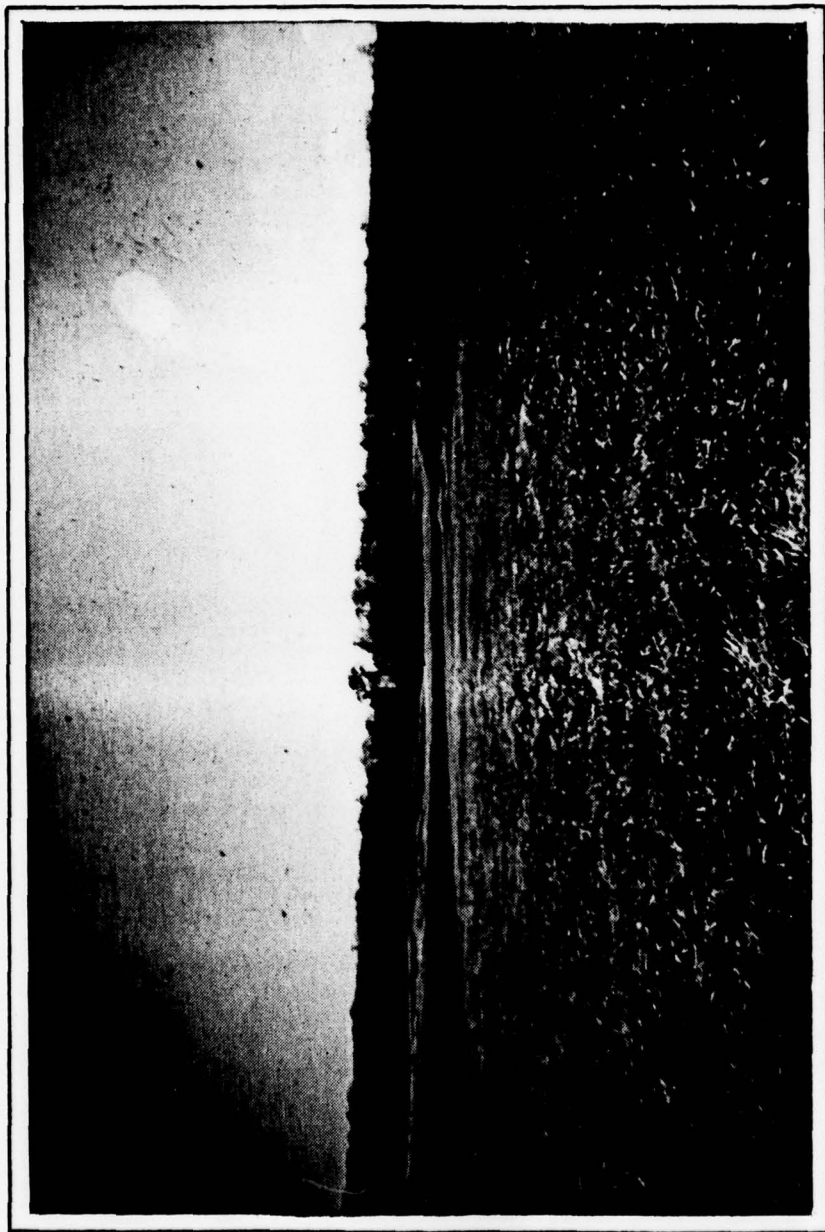
PHOTOGRAPH NO. 5

2. Emergency Spillway. The grass-lined emergency spillway at the left abutment was inspected and found to be quite stable and in good condition. Side slopes are well vegetated and appear to be well maintained. The emergency spillway entrance and exit channels and control section are considered to be in good condition.

OVERVIEW OF EMERGENCY SPILLWAY LOOKING
DOWNSTREAM. NOTE GRASS COVERED BORROW
PIT ON THE LEFT SIDE OF THE CHANNEL.

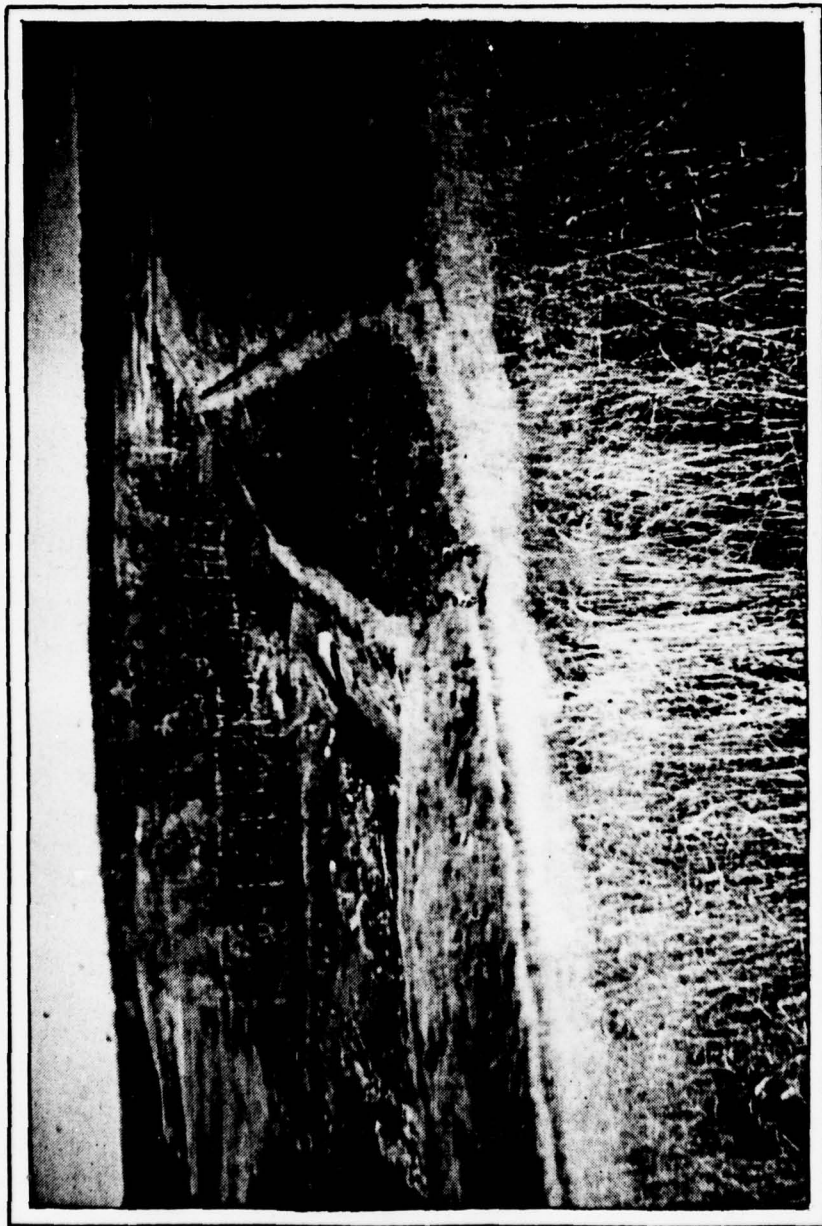
OVERVIEW OF UPSTREAM SLOPE LOOKING
TOWARDS LEFT ABUTMENT.

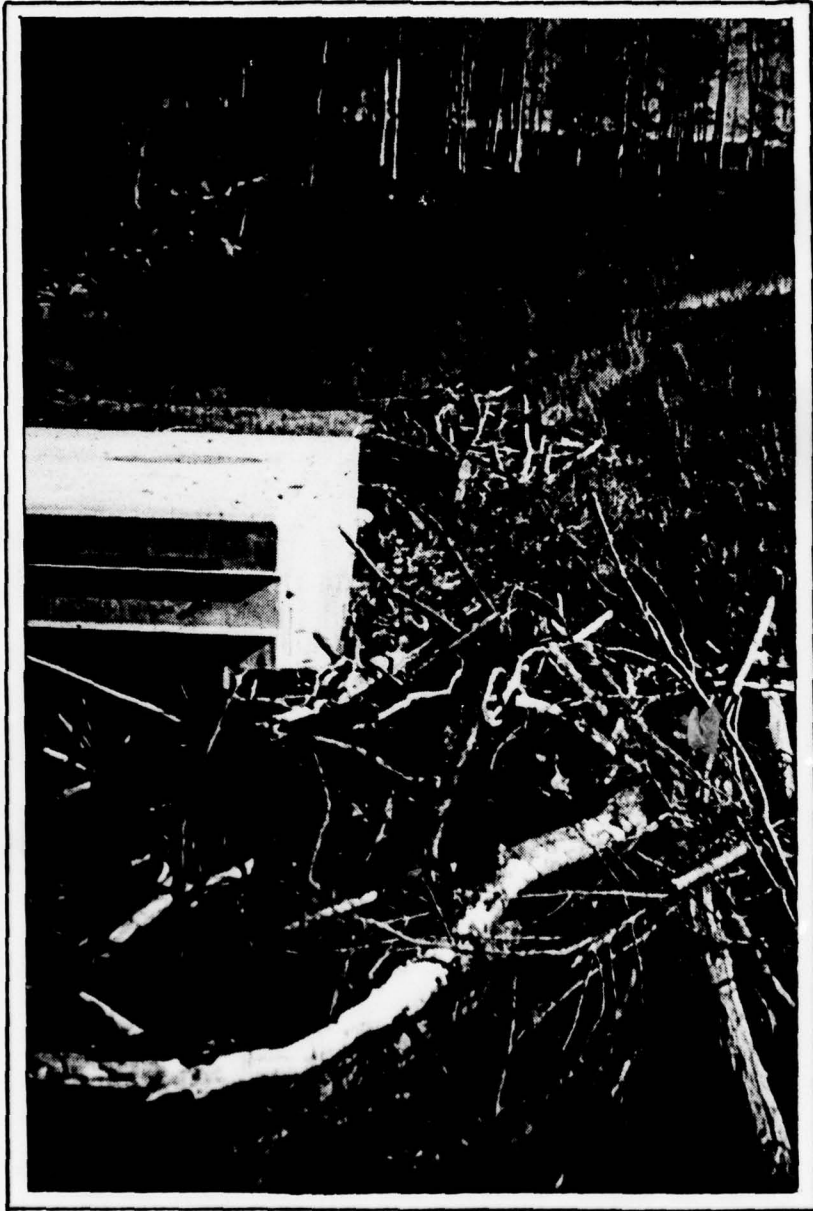
PHOTOGRAPH NO. 8

There is very little debris noted along the reservoir shoreline or along the slopes of the drainage area. However, debris had been collected and piled on the embankment near the riser. All of the drainage area is considered to be well vegetated and stable.

SLOPES	The reservoir side slopes are moderate to steep and generally wooded. There is considerable debris, including fallen trees, that could block the principal spillway. There are two piles of debris near the riser that appear to have been cleaned from the riser. This debris should be removed or burned to insure that it cannot block the riser inlet again.	
--------	--	--

TRASH REMOVED FROM INTAKE RISER
AND PILED AROUND STRUCTURE.

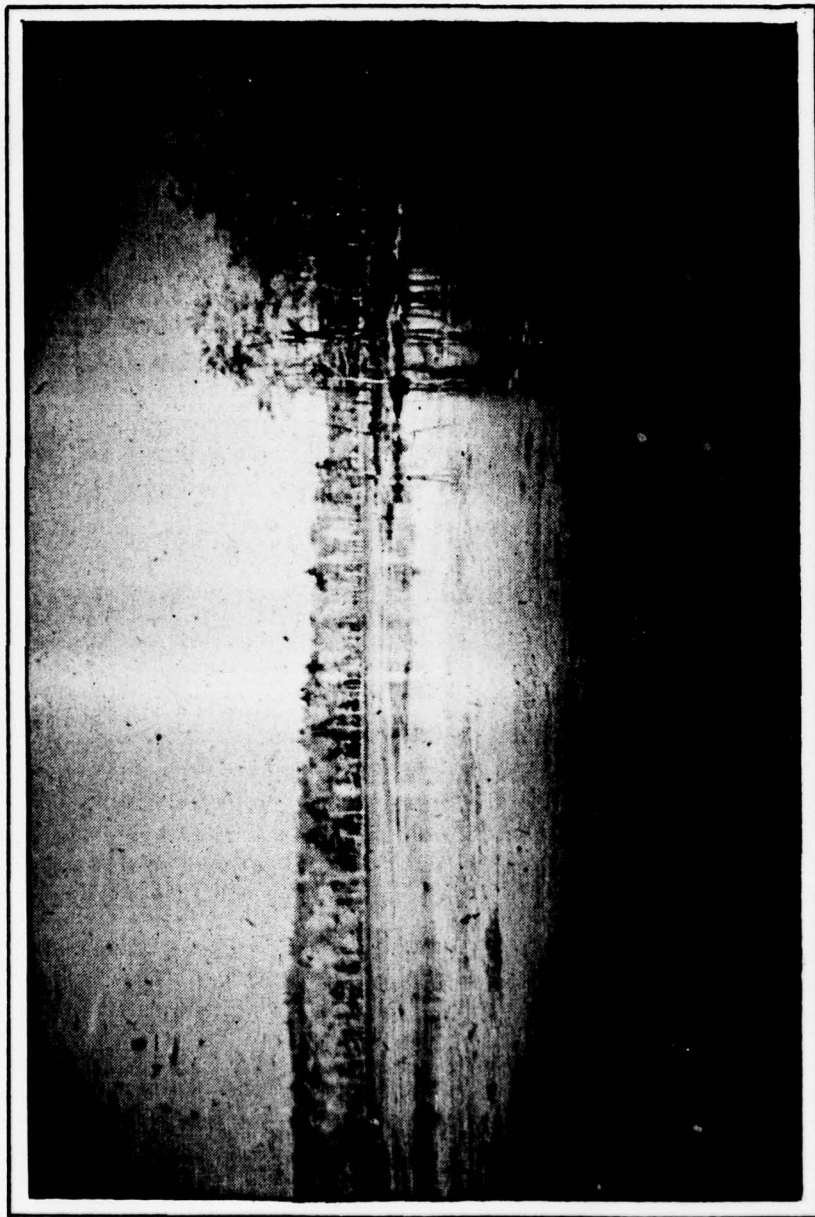
PHOTOGRAPH NO. 9

OVERVIEW OF UPSTREAM LAKE.
RANSBERRY POND
